Final Report

Investigation Into Service Quality Provided By Public Service Company Of New Hampshire Within The Town of Bedford, New Hampshire

For:
**New Hampshire
Public Utilities Commission
Docket No. DE 03-113**

Prepared by
Dufresne-Henry

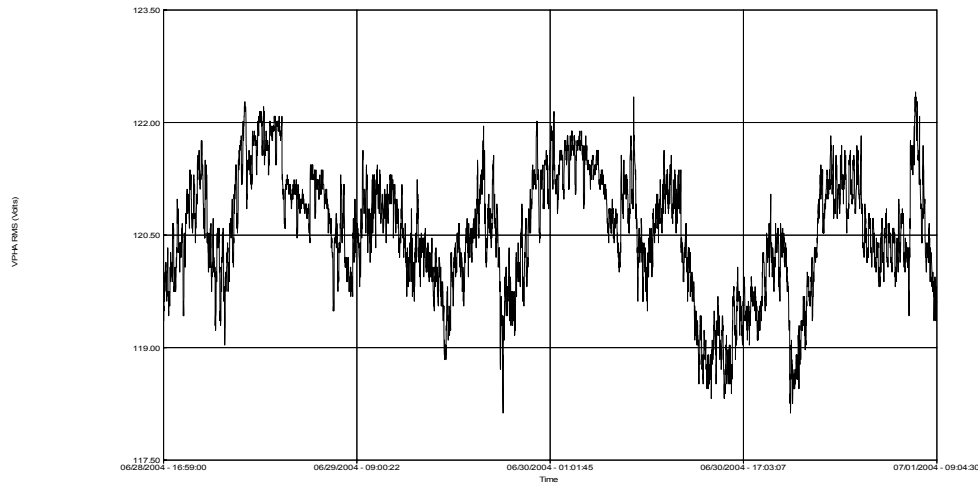
FIGURE 7.1.1.1B RMS Voltage Recording at Town Hall during Monitoring Period 6/28 - 7/1

A total of 12 harmonic events were logged, of which 7 were captured by one or both of the AEMC and CH meters. These impulse events appear to be related to capacitor switching (see Section 8 for more information).

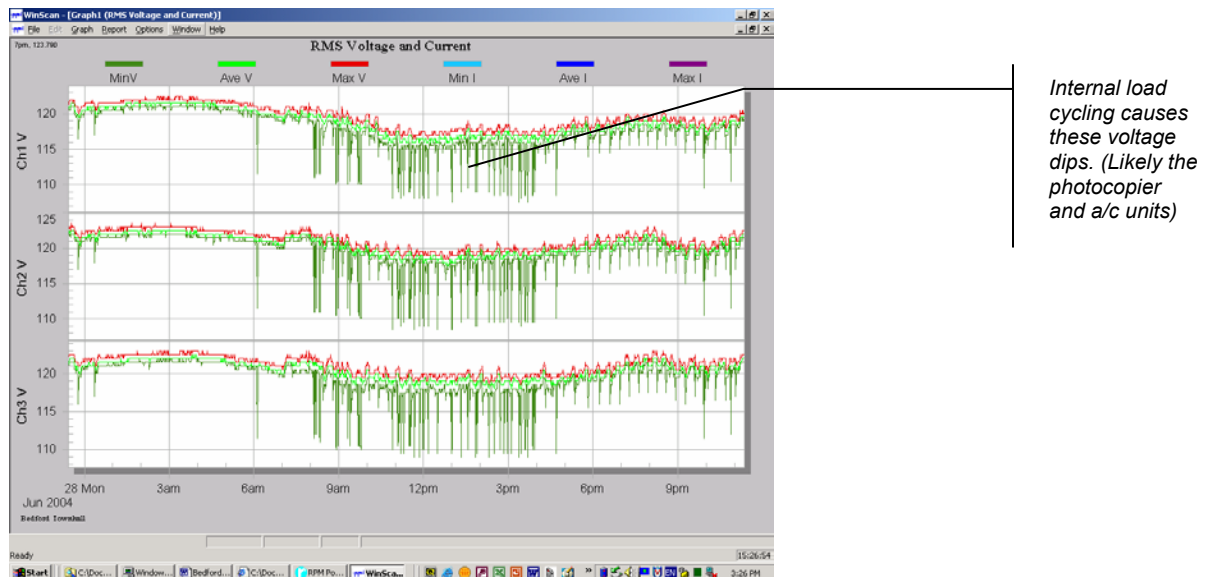
FIGURE 7.1.1.2 Town Hall panel during the 6/28 9:00/9:30/10:00/10:30 capacitor switching on 3W2

Voltage sags and dips were observed during the hours when the office was open (see Section 8).

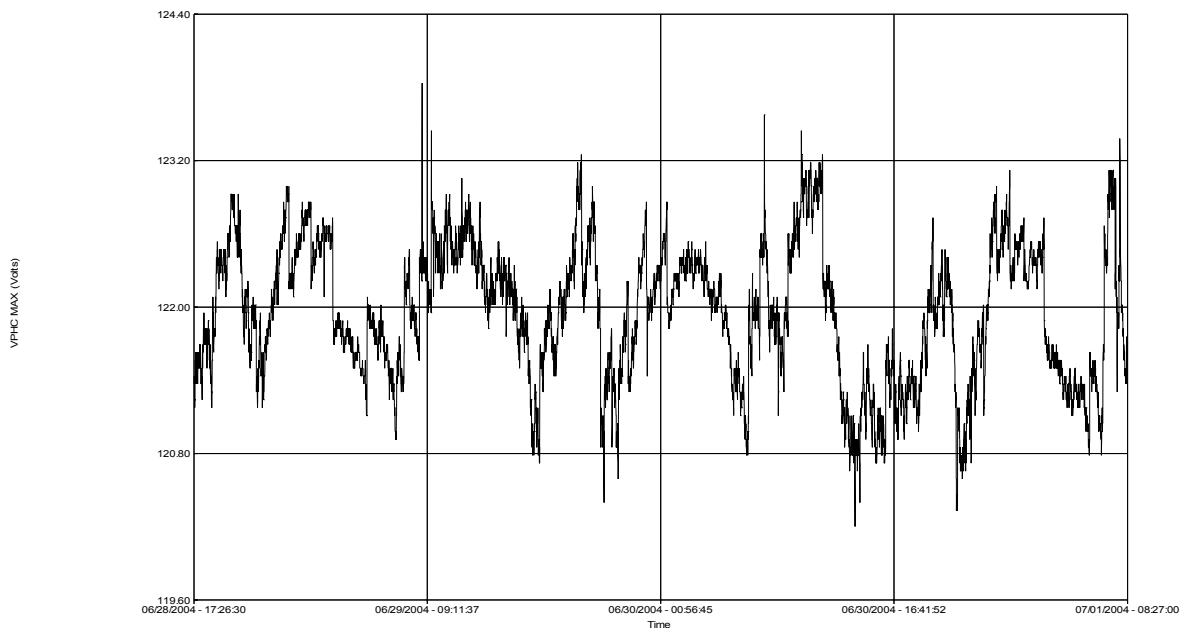
Figure 7.1.2.1 RMS Voltage Recording at McKelvie School during Monitoring Period

A total of 10 harmonic events were logged on this feeder, of which 9 were captured by both of the PA-9Plus meters at the same time. These appear to be impulse events related to capacitor switching on the primary system since they affected both meters.

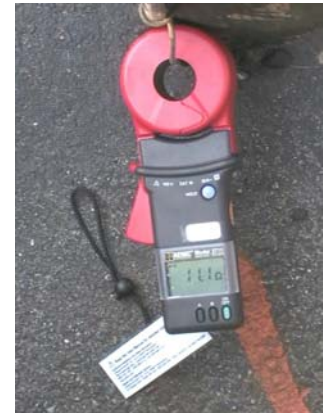
The ground resistance at pole 18/40 on County Road was varying so three measurements were taken. The ground resistance readings were 4.6 ohms, 10.7 ohms and 11.1 ohms and the ground current was 34 mA at the time of the meter installation.

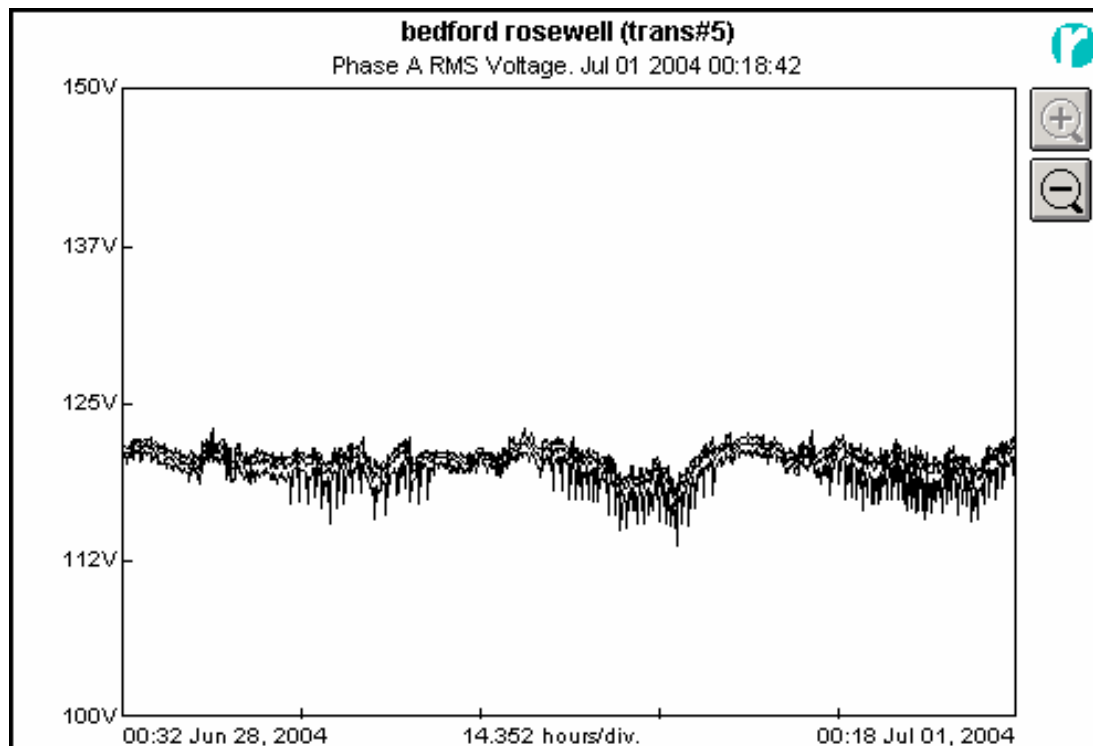
FIGURE 7.1.3.1A Bedford Rosewell (Transformer #5)

PSNH installed an RPM Voltage Monitor inside pad-mounted transformer T5. The data indicated that the voltage remained within NHPUC limits for the duration of the test period, including the time when the capacitors and voltage regulator were removed from service.

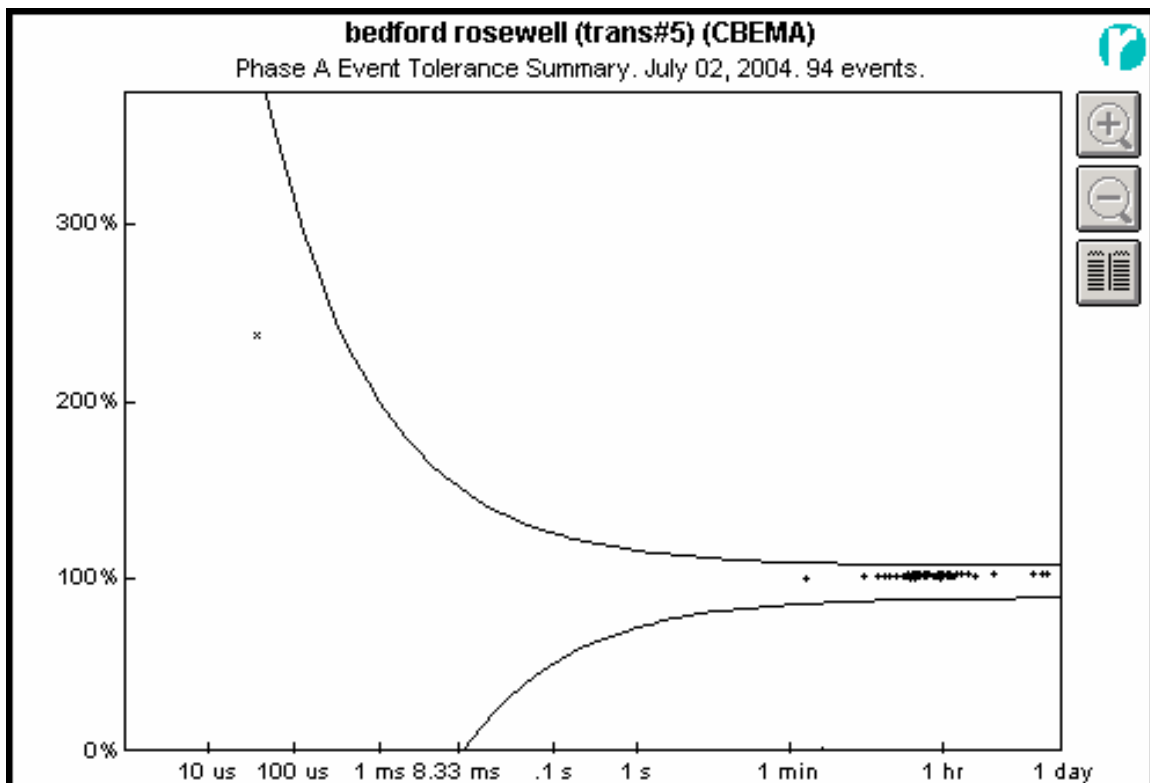
FIGURE 7.1.3.1B Bedford Rosewell (Transformer #5) (CBEMA)

The individual voltage events during the capacitor and regulator removal periods remained within the CBEMA curve limits, a standard developed by computer and business equipment manufacturers to define allowable power quality. The CBEMA curve is now known as the 1996 ITI Curve, as developed by the Information Technology Industry Council, and specifies that equipment should be able to withstand voltage variations of +/- 10% for durations over 10 seconds. The following graph shows that the voltage remains within these requirements.

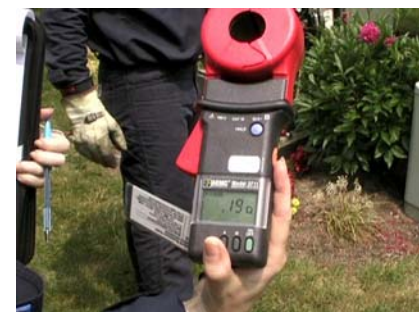
The ground resistance at transformer T5 was 0.19 ohms with a ground current of 234 mA at the time of meter installation.

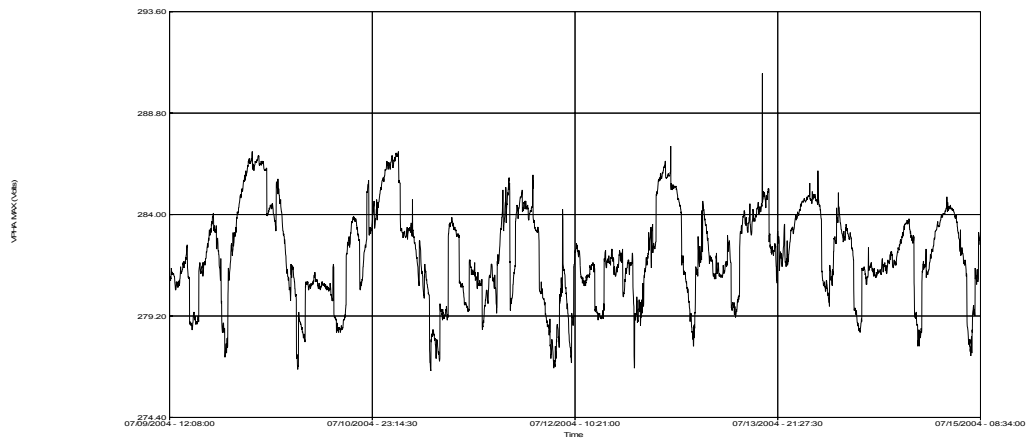
The recorded voltage was found to be on the high side of nominal and the maximum voltage recorded on Phase A was 290.7 volts which exceeded the NHPUC limit by 2.7 volts (0.9 volts on 120 volt base). Upon further analysis, this was found to be a single overvoltage event captured during the entire six day monitoring period as shown on Figure 7.2.1.1.

FIGURE 7.2.1.1 Donald Street Voltage Recording During Test Showing One Overvoltage Event on Phase A

Figure 7.2.1.1 shows the voltage variation during the entire recording period and the voltage typically varies as expected. The voltage remained within the NHPUC voltage limits, except for a single overvoltage event that occurred on July 13, 2004 at 6:48 PM was recorded as 290.7 volts.

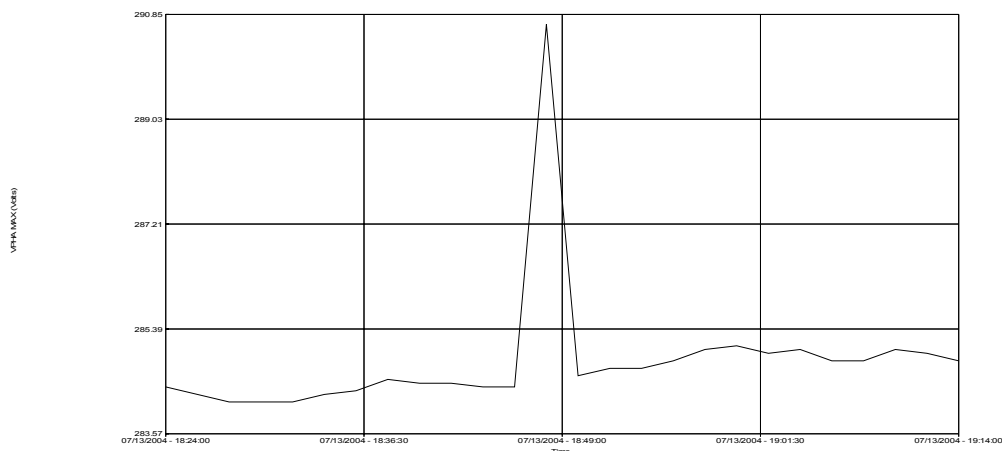
FIGURE 7.2.1.2 Donald Street Voltage Recording During Test Showing Detail of Overvoltage Event on Phase A

This event is magnified in Figure 7.2.1.2 which shows an overall time duration of four minutes from start to finish, but only about two minutes above the 288 volt limit. The meter was set to capture voltage measurements for each cycle and record the values on a two minute interval. Our monitoring confirms that the voltage on this circuit was maintained within NHPUC limits for the entire duration of the monitoring period.

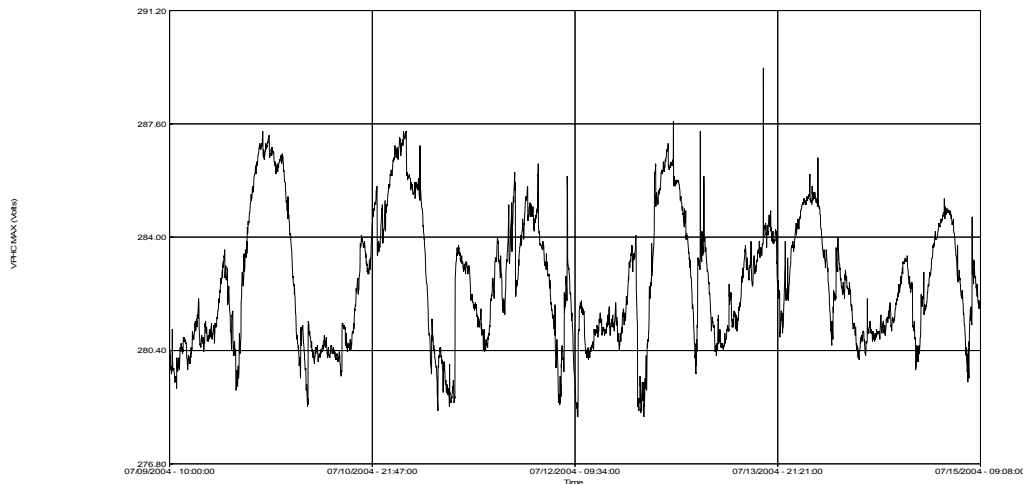
FIGURE 7.2.2.1 Riddle Brook School Voltage Recording During Test Showing Overvoltage Event on Phase C

Figure 7.2.2.1 shows the voltage variation during the recording period and the voltage varies as expected. There is a single overvoltage event that occurred on July 13, 2004 at 6:48 PM that was recorded as 289.4 volts. This event was the same one recorded at Donald Street at the same time and is magnified in Figure 7.2.2.2.

The apparent discrepancy of this event recorded on Phase A at Donald Street and Phase C at Riddle Brook is the result of independent meter connections at both locations without attempting to match phase wire connections between monitoring locations. This event was captured on only one phase at both locations and the discussion under Donald Street is applicable here for the same event.

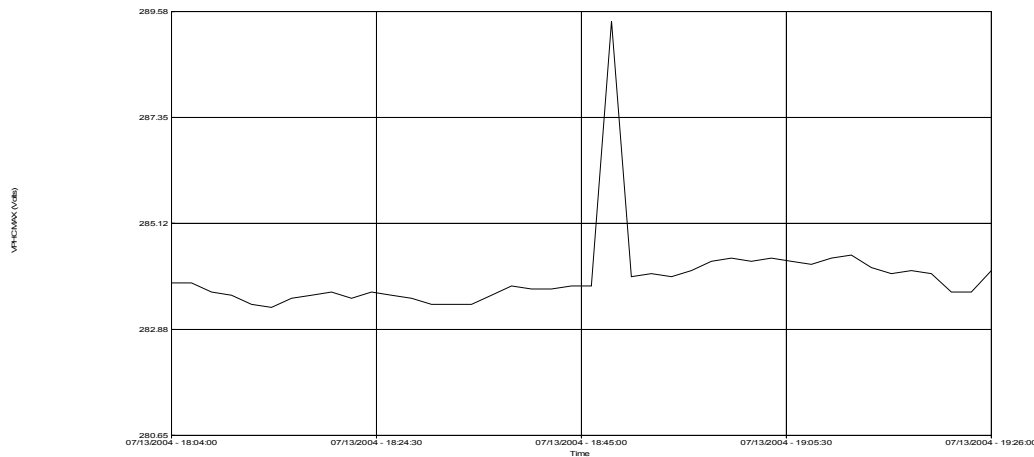
FIGURE 7.2.2.2 Riddle Brook School Voltage Recording During Test Showing Detail of Impulse on Phase C

This event is magnified in Figure 7.2.2.2 which shows an overall time duration of four minutes from start to finish, but only about two minutes above the 288 volt limit. The meter was set to capture voltage measurements for each cycle and record the values on a two minute interval. Our monitoring confirms that the voltage on this circuit was maintained within NHPUC limits for the entire duration of the monitoring period.

The voltage measurement at Riddle Brook School remained within NHPUC limits for the entire duration of the monitoring period.

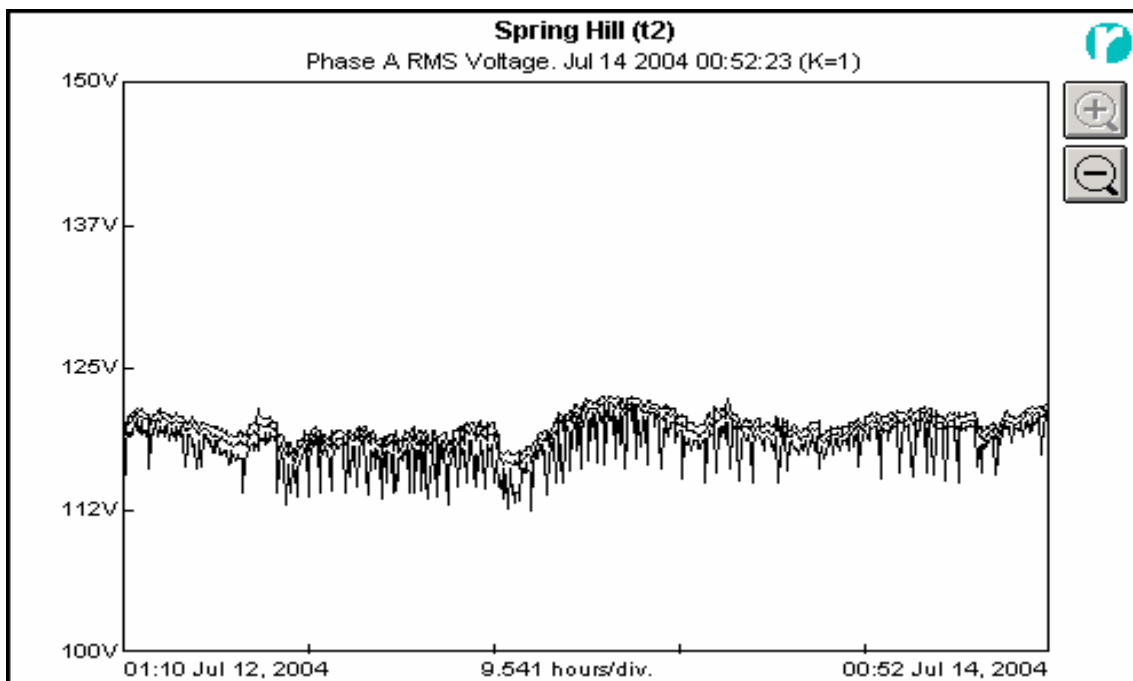
FIGURE 7.2.5.1A Spring Hill Phase A during the 7/12 cap switching on pole 25/93 New Boston Road and during the 7/13 cap switching on pole 25/93 New Boston Road

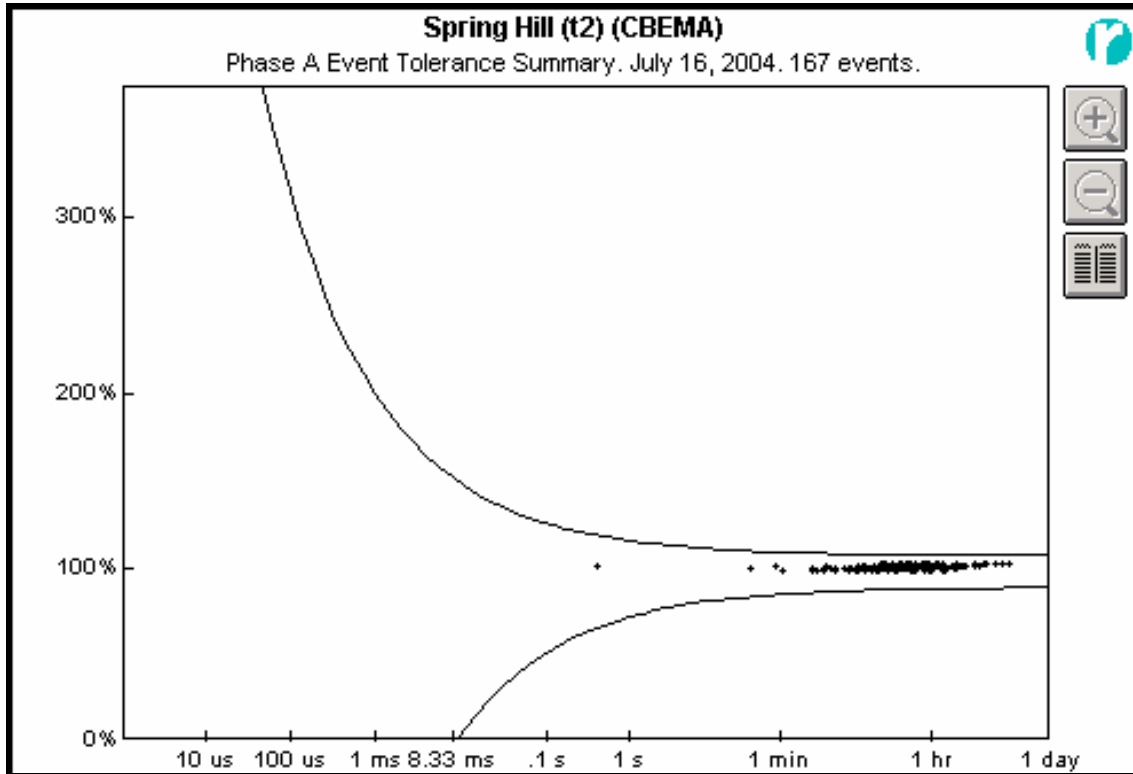
FIGURE 7.2.5.1B Spring Hill Phase A&B voltage events vs CBEMA curve during the 7/12 cap switching on pole 25/93 New Boston Road and during the 7/13 cap switching on pole 25/93 New Boston Road

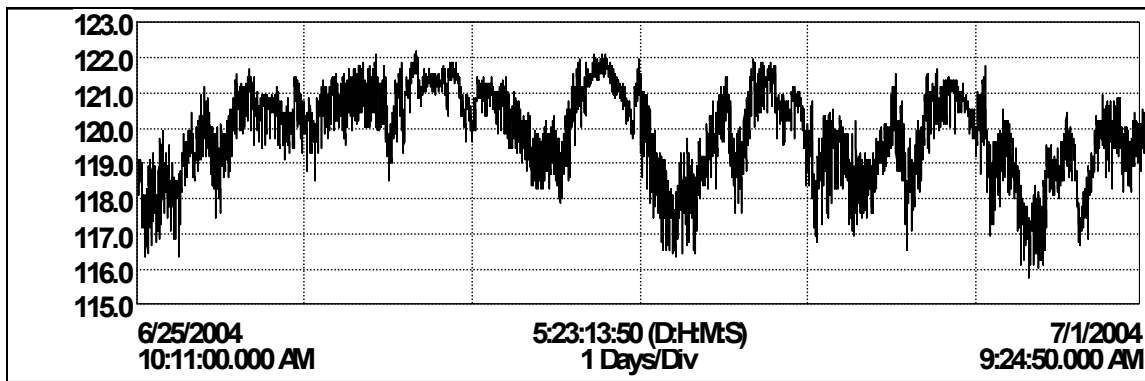
FIGURE 8.2.1.1 RMS Voltage Recorded Inside the Town Hall

The average branch circuit voltage recorded in the town hall ranged from 115.7 to 122.0 Volts, as shown on the voltage graphs. A single maximum voltage of 123.4 volts was recorded and several voltage sags dipped below 108 volts.

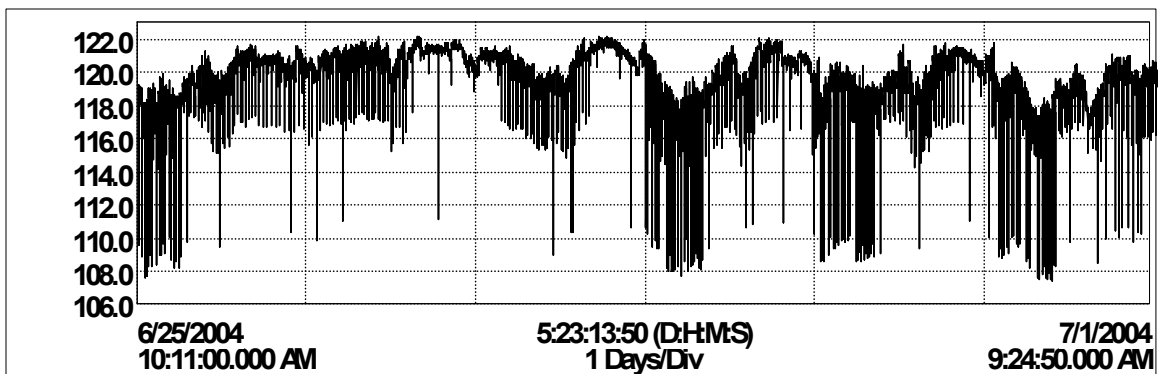
The frequent voltage sags recorded in the town hall were observed by the PA-9Plus pole mounted meter, but not to the same degree as measured in the building. This indicates that the apparent cause is located within the building.

FIGURE 8.2.1.2 RMS Minimum Voltage Recorded Inside the Town Hall showing Voltage Sags

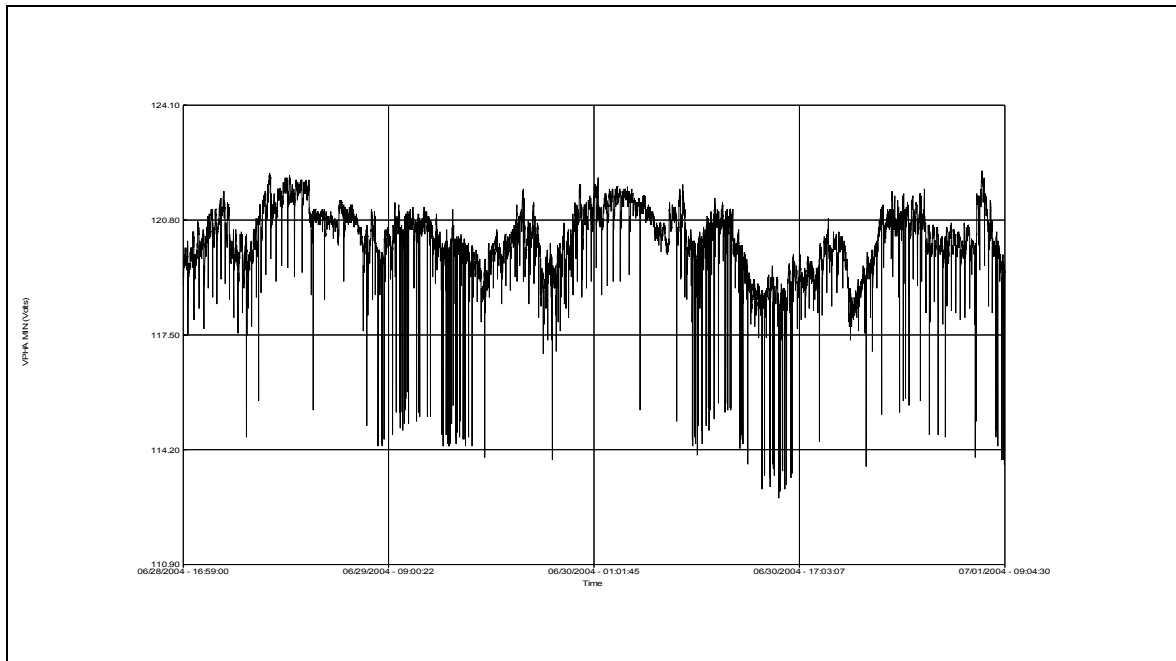
FIGURE 8.2.1.3 Phase A RMS Minimum Voltage Recorded on Pole showing Voltage Sags at Utility Transformer Secondary Terminals

These two graphs indicate that the voltage sags caused by equipment inside the Town Hall impact the transformer serving the building. If other customers were connected to this transformer, they would also be affected by the voltage sags. The transformer provides a fair degree of isolation so these sags have little impact on the primary line voltage.

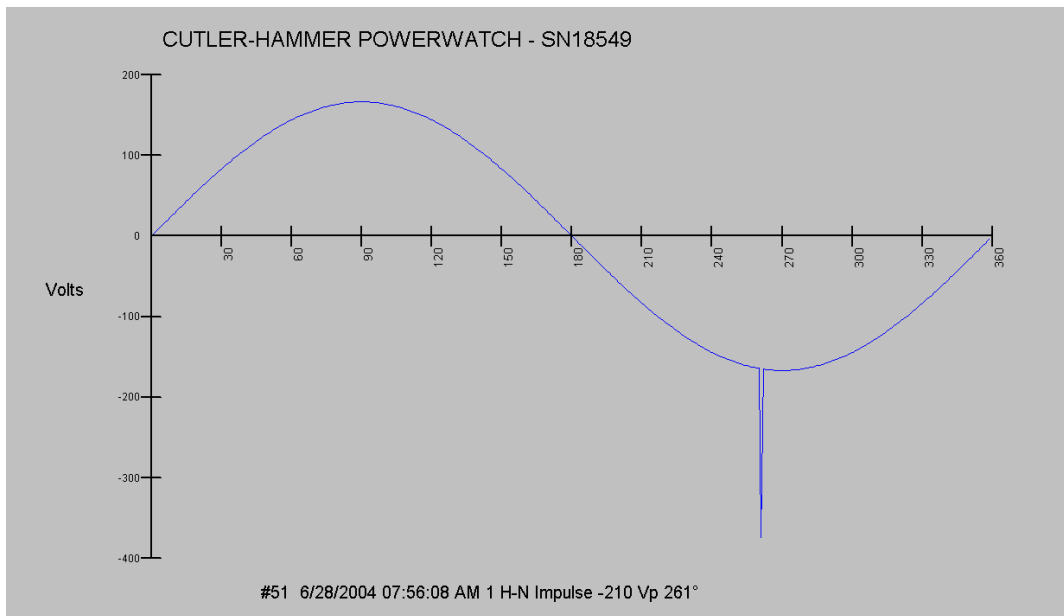
FIGURE 8.2.2.1 Switching Transient Caused by Capacitor Switching On – Negative Impulse

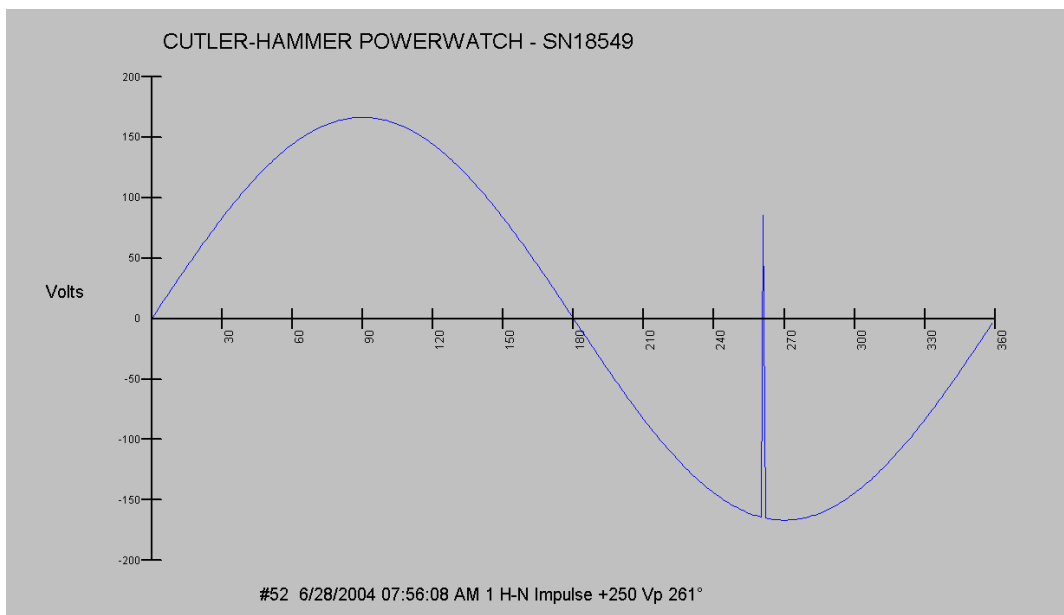
FIGURE 8.2.2.2 Switching Transient Caused by Capacitor Switching On – Positive Impulse

This is a typical waveform. These transients were also observed by the other meters; however the magnitudes of the impulses were not as great due to differences in meter characteristics. The waveform for this impulse was captured on the AEMC meter and the waveform distortion shown is typical. (The time recorded on this meter is slightly different as the meter clocks could not be synchronized.)

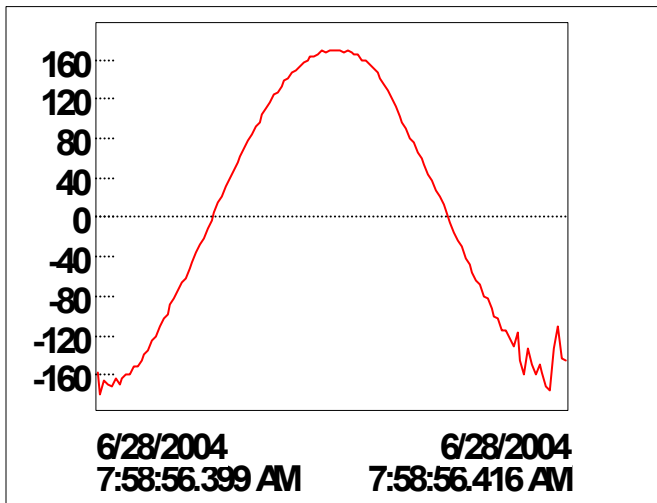
FIGURE 8.2.2.3 Same Switching Transient Captured on AEMC Meter

Impulses of this type are infrequent and we only found them when capacitors were switched on, but not every time of switching. The purpose of this illustration is to indicate that system disturbances may occur from time to time on the utility system. We did not find any unusual impulses or voltage spikes beyond capacitor switching.

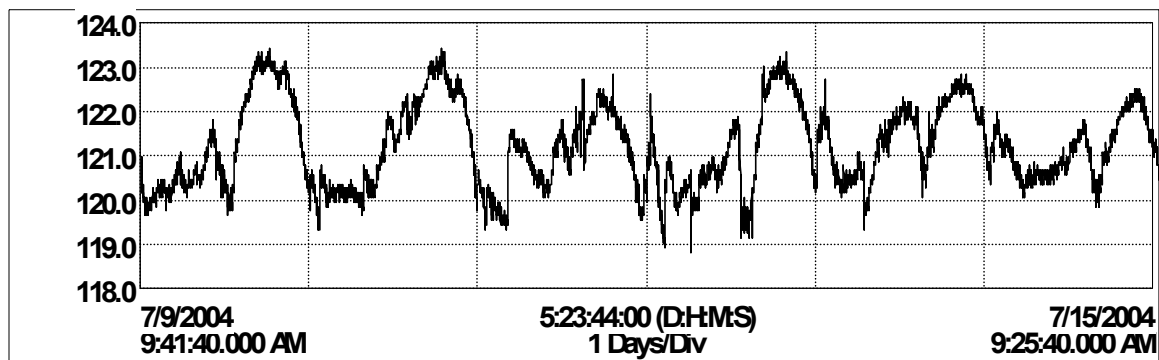
FIGURE 8.3.1.1 RMS Voltage Recorded Inside the Riddle Brook School

The highest voltage reading is approximately equivalent to the data above and would be expected during periods of light load in the building. Note that the width of the line is narrower than that on some other graphs and indicates very little short term voltage variation.

The lowest voltage is the voltage at the transformer minus losses in the service and internal building wiring. Voltage drops would be expected to increase during periods of heavier power use when the building is fully operational. The graph shows that most events are voltage sags, which may be caused by the inrush current when motorized equipment starts. In any case, the voltage remained within NHPUC limits.

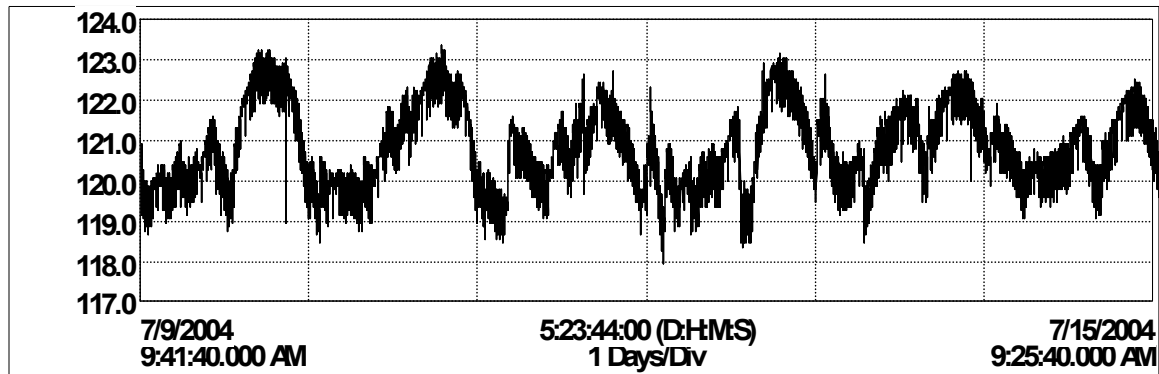
FIGURE 8.3.1.2 RMS Minimum Voltage Recorded Inside the Riddle Brook School

In this case, the line width is wider than the previous and indicates numerous short term voltage variations but no significant sags, such as observed in the Town Hall.
